**Flood Control Project Maintenance
Levee Inspections**
LMA District Cover Sheet
Spring 2019 Levee Inspection Results

Sacramento Maintenance Yard Sacramento Bypass

Spring 2019 Levee Inspection Results

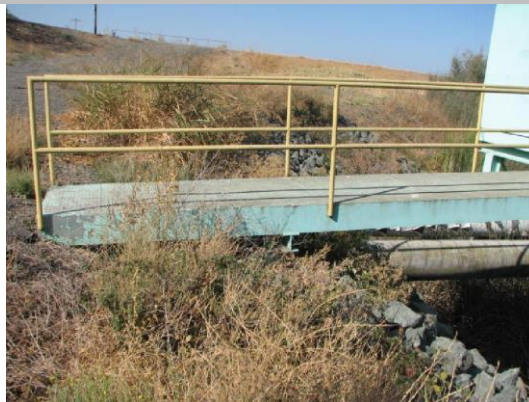
Photo 3 of 3 : UCIP_SP_2019_44783_20608.jpg

Comment Code						
Inspector Comment						
FS_ID:44783 DS_ID:19066 EP_NO: 13616 Repair Type: Non-Urgent Crossing Status: Found UCIP Comments: After more investigation depressions are from water run off. erosion repair needed FIELD_STRUCT_DESC: [Agricultural Drainage Pumping System] 1 of 2: 24-inch concrete encased steel discharge pipeline through the right bank (north) levee of the Sacramento Bypass, 6.33 feet below the crown. Siphon breaker on the waterside (WS). Vertical galvanized iron pipe trash rack on the inlet structure. (24-inch pipeline authorized under Permit No. 13616, 1995 - Reclamation District No. 537 [revised]). FS Date: 4/28/2015 2:43:01 PM

Landside view: walkway to the pump house.

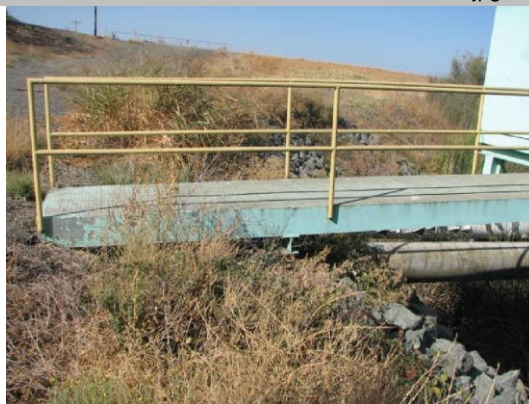
Photo 2 of 3 : UCIP_SP_2019_44784_20618.jpg

Comment Code					
Inspector Comment					
FS_ID:44784 DS_ID:19079 EP_NO: 13616 Repair Type: Non-Urgent Crossing Status: Found UCIP Comments: Horizontal Air vent on waterside slope. Green vegetation and depressions also found on waterside slope. FIELD_STRUCT_DESC: [Agricultural Drainage Pumping System] 2 of 2: 20-inch concrete encased steel discharge pipeline through the right bank (north) levee of the Sacramento Bypass, 6.33 feet below the crown. Siphon breaker on the waterside (WS). Vertical galvanized iron pipe trash rack on the inlet structure. (24-inch pipeline authorized under Permit No. 13616, 1995 - Reclamation District No. 537 [revised]). FS Date: 4/28/2015 2:43:26 PM

Landside view: walkway to the pumping plant

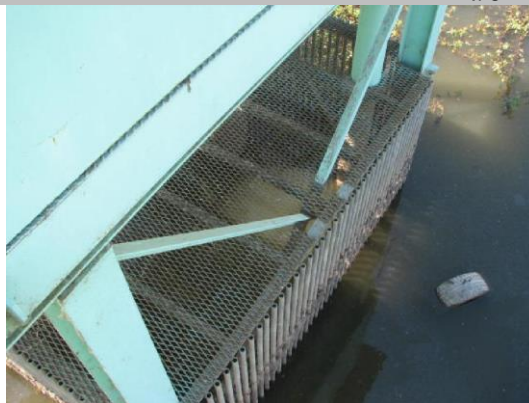
Photo 3 of 3 : UCIP_SP_2019_44784_20617.jpg

Comment Code						
Inspector Comment						
FS_ID:44784 DS_ID:19079 EP_NO: 13616 Repair Type: Non-Urgent Crossing Status: Found UCIP Comments: Horizontal Air vent on waterside slope. Green vegetation and depressions also found on waterside slope. FIELD_STRUCT_DESC: [Agricultural Drainage Pumping System] 2 of 2: 20-inch concrete encased steel discharge pipeline through the right bank (north) levee of the Sacramento Bypass, 6.33 feet below the crown. Siphon breaker on the waterside (WS). Vertical galvanized iron pipe trash rack on the inlet structure. (24-inch pipeline authorized under Permit No. 13616, 1995 - Reclamation District No. 537 [revised]). FS Date: 4/28/2015 2:43:26 PM

Landside view: vertical GI pipe trash rack in inlet structure.

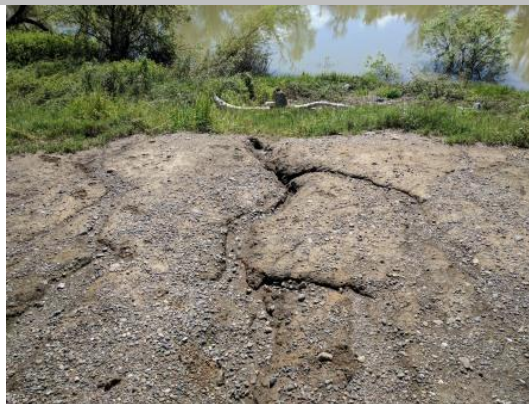
Photo 1 of 1 : SP_2019_ST0008_284_15_20190304_00004.jpg

LM Start	1.74	Rating **	A/W	Issue No.	15
LM End	1.74	Issue Type +	Ma	Location *	WS
Category	Earthen Levee			GPS Latitude/Longitude	
				Start	End
Item	Erosion / Bank Caving			38.599546 °	38.599546 °
				-121.590235 °	-121.590235 °
DWR ID	DWR_ST0008_01_s_2018_15				
Comment Code					
E1 : Note and monitor erosion site.					
Inspector Comment					
There is runoff erosion on the oversized levee section located on the waterside levee slope. Recommend monitoring.

View of erosion on waterside slope. Spring 2017.

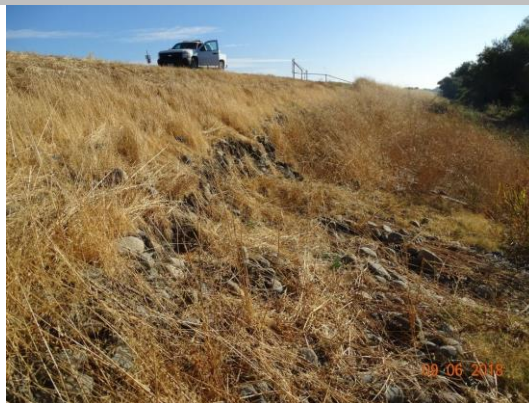
Photo 1 of 4 : SP_2019_ST0008_285_1_20190304_00001.jpg

LM Start	1.26	Rating **	A/W	Issue No.	1
LM End	1.79	Issue Type +	Ma	Location *	
Category	Supplemental		GPS Latitude/Longitude		
			Start	End	
Item	2017 Storm Damage		38.597023 °	38.594527 °	
			-121.577558 °	-121.586638 °	
DWR ID	DWR_ST0008_02_f_2017_1

Notes: Minor wavewash on landside levee slope; no active erosion; no cross section taken, photo only. The erosion is not within the prism. Sac Yard will fix after vegetation gets burned. Fall 2018.

View of the worst section of erosion, just past the gate near the end of the unit. Fall 2018.
